SERVICE BULLETIN

Date: March 18, 1994

Units Affected: Ampeg SVT-III & AP-3550  
All units, domestic and export.

Subject: Possible shock hazard under some conditions.

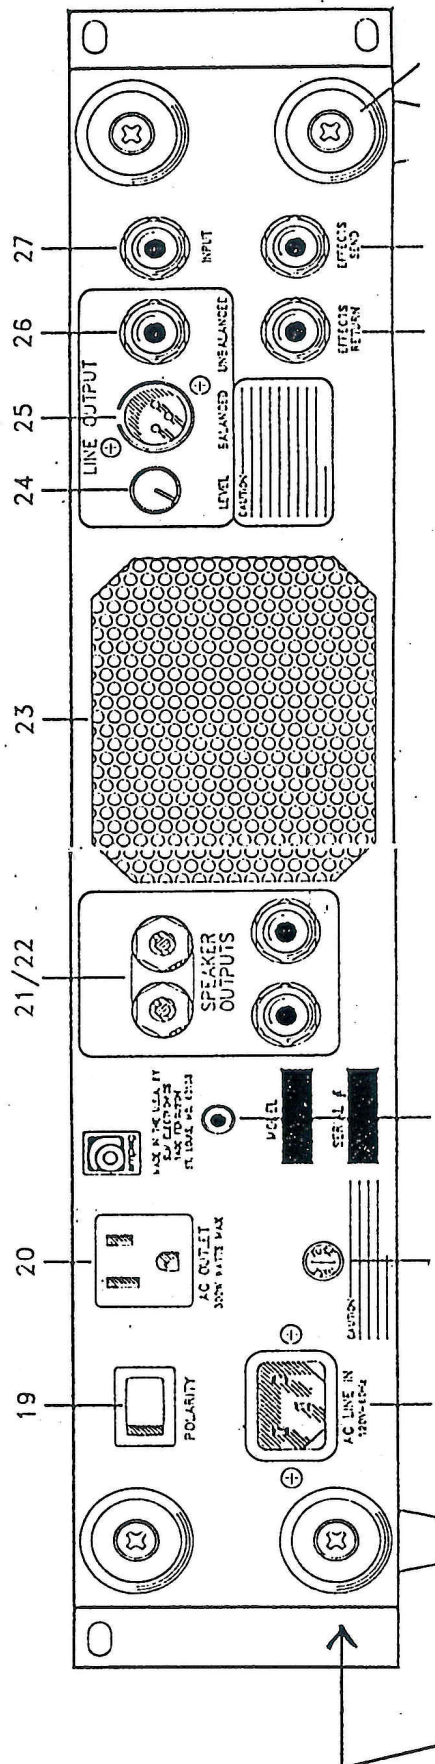
SVT-III

Some units were built with too long a screw used to attach one of the large plastic feet to the rear panel (not the smaller rubber feet on bottom of unit). The screw in question is the one that attaches the large plastic foot nearest the line cord input connector on the rear chassis panel. (See drawing page 2.) This is the lower left foot if facing the rear panel of the unit. (Not the rubber feet on bottom of unit.) The possibility exists of this screw coming in contact with the internal Faston connector which is connected to the AC Neutral input of the unit.

1) FACING REAR OF THE UNIT - REMOVE SCREW FROM LOWER LEFT FOOT AND DISCARD.

2) RE-ATTACH FOOT USING # 8-32 3/4" SCREW (30-833-75) AND A # 8 WASHER (30-835-01).
